U.S. CHEMICAL SAFETY AND HAZARD INVESTIGATION BOARD

INVESTIGATION REPORT

CATASTROPHIC VESSEL OVERPRESSURIZATION (4 DEATHS)

Sonat Exploration Company
Temple 22-1 Common Point Separation Facility
Pitkin, Louisiana
March 4, 1998

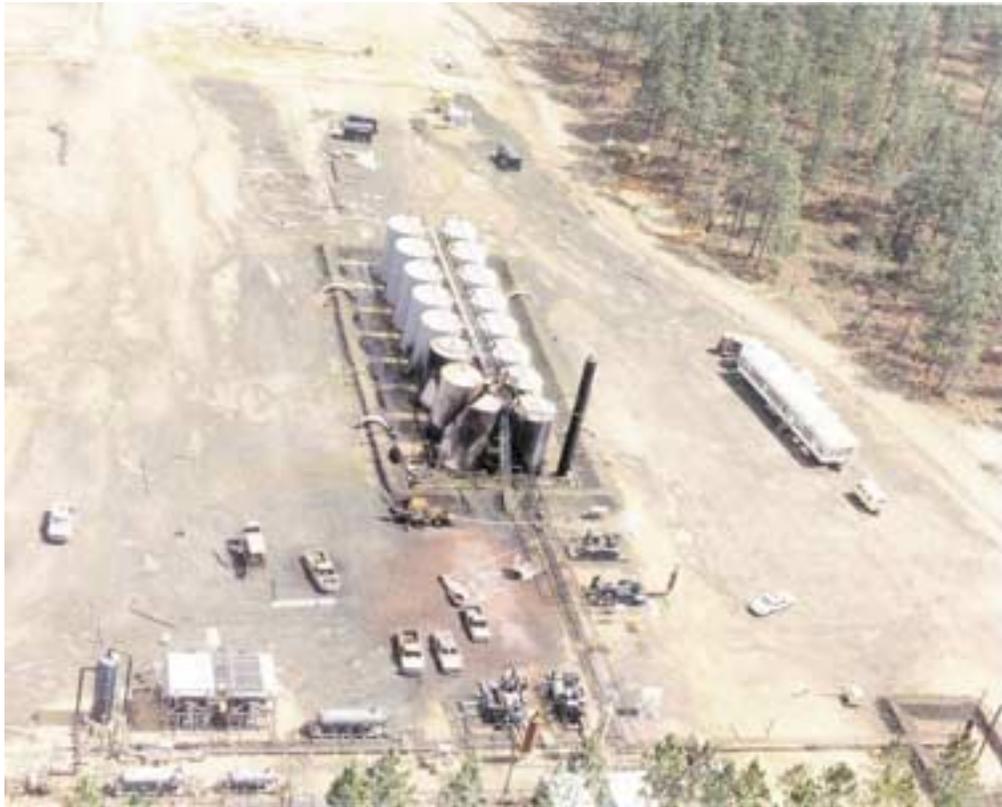
Figure 1. Aerial View of the Temple 22-1 Common Point Separation Facility after the Incident

In addition to the fatalities, the incident resulted in about \$200,000 worth of damage, including the destruction of the third-stage separator, four private vehicles, and a backhoe and damage to the facility storage tanks. Figures 1, 7, and 8 document the condition of the facility after the incident.

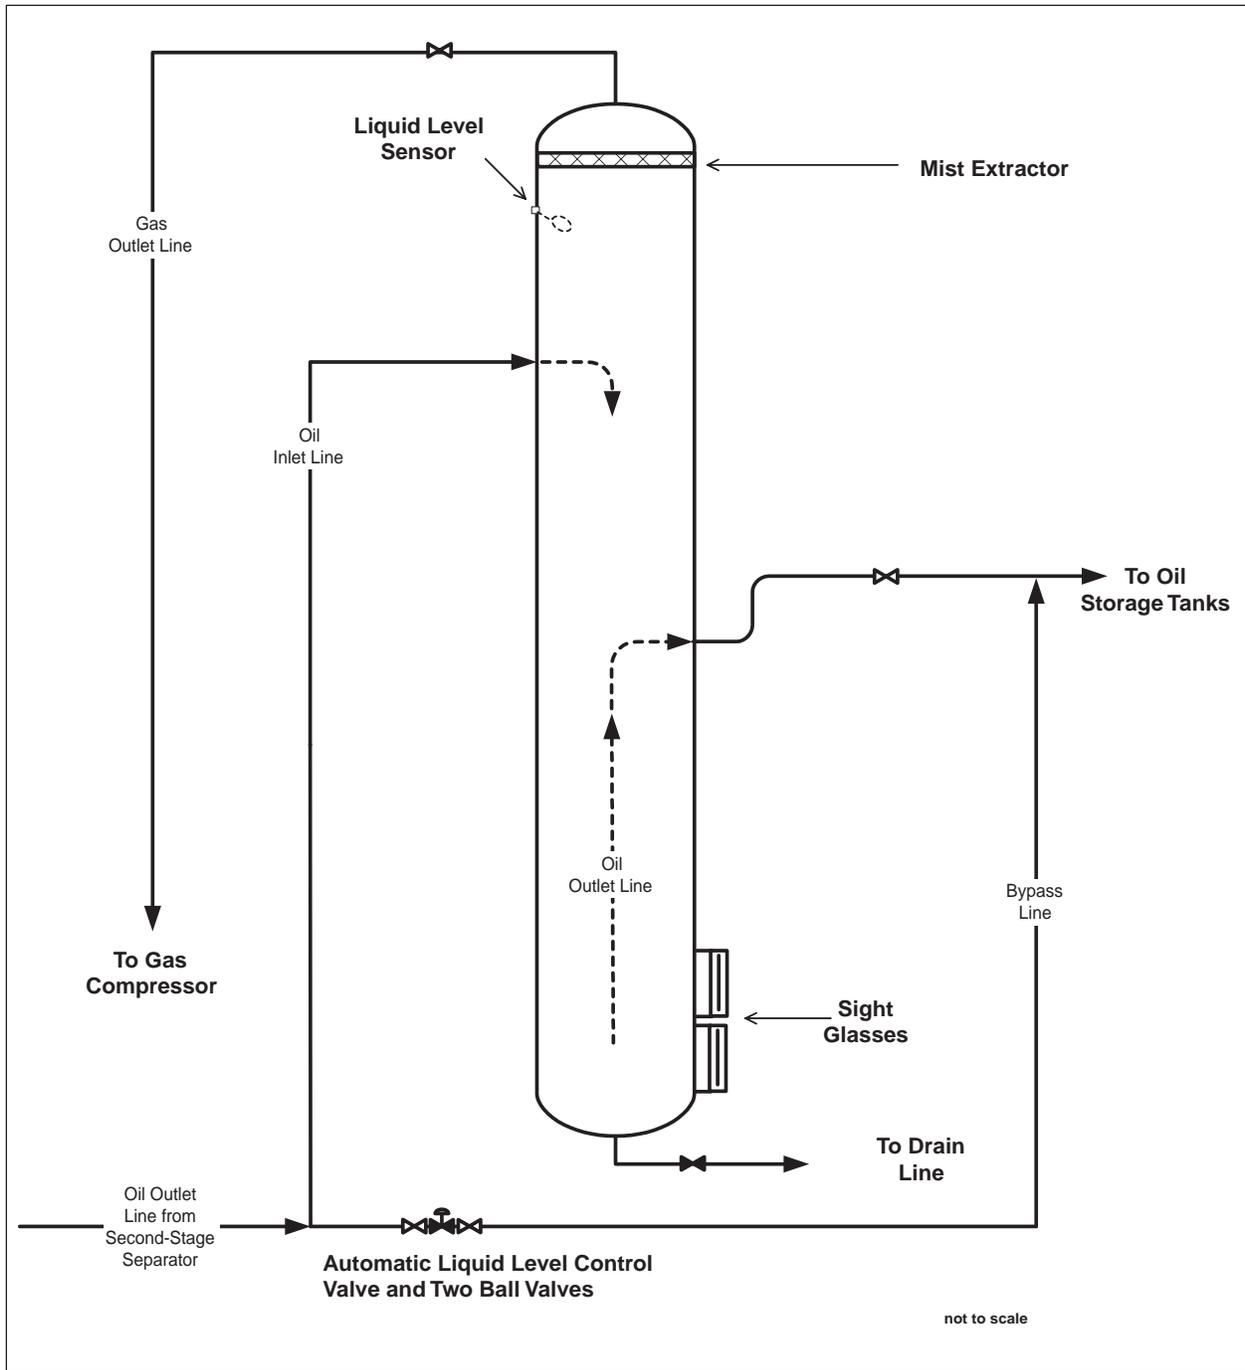
Each third-stage separator (Bulk and Test) was a 45-foot-tall vessel with a diameter of four feet (see Figure 4 for details). In operation, the vessel would be approximately 80% full with fluid. Well fluid was introduced into the separator at a height of approximately 35 feet, and separated

Figure 4. Third-Stage Separator Schematic

The third-stage separator was only rated for atmospheric pressure service (14.7 psia). Vessel failure was the result of overpressurization by purge gases and was both sudden and catastrophic. Four personnel were within 40 feet of the third-stage separator at the time it ruptured.²⁷

Another design deficiency was the absence of an inlet block valve upstream from the third-stage separator. Such a valve could have been used to isolate the separator from the high-pressure purge gases that caused the vessel failure. An inlet block valve would be an adjunct, not a substitute, for a pressure-relief system on the separator. Similarly, the inclusion of a block valve (15) on the oil outlet line of the third-stage separator allowed the separator to be isolated from the storage tanks, whose roof hatches offered a potential means of venting. The third-stage separator also had an outlet line to a gas compressor; excess flow into the compressor would be vented via the gas flare. However, the gas outlet line also was equipped with a block valve (valve 14). At the time of the incident, the compressor was out of service and valve 14 was closed.³⁴

Prior to operating the Bulk Train, the third-stage separator should thus have been equipped with a pressure-relief system, as recommended by API consensus guidance.³³

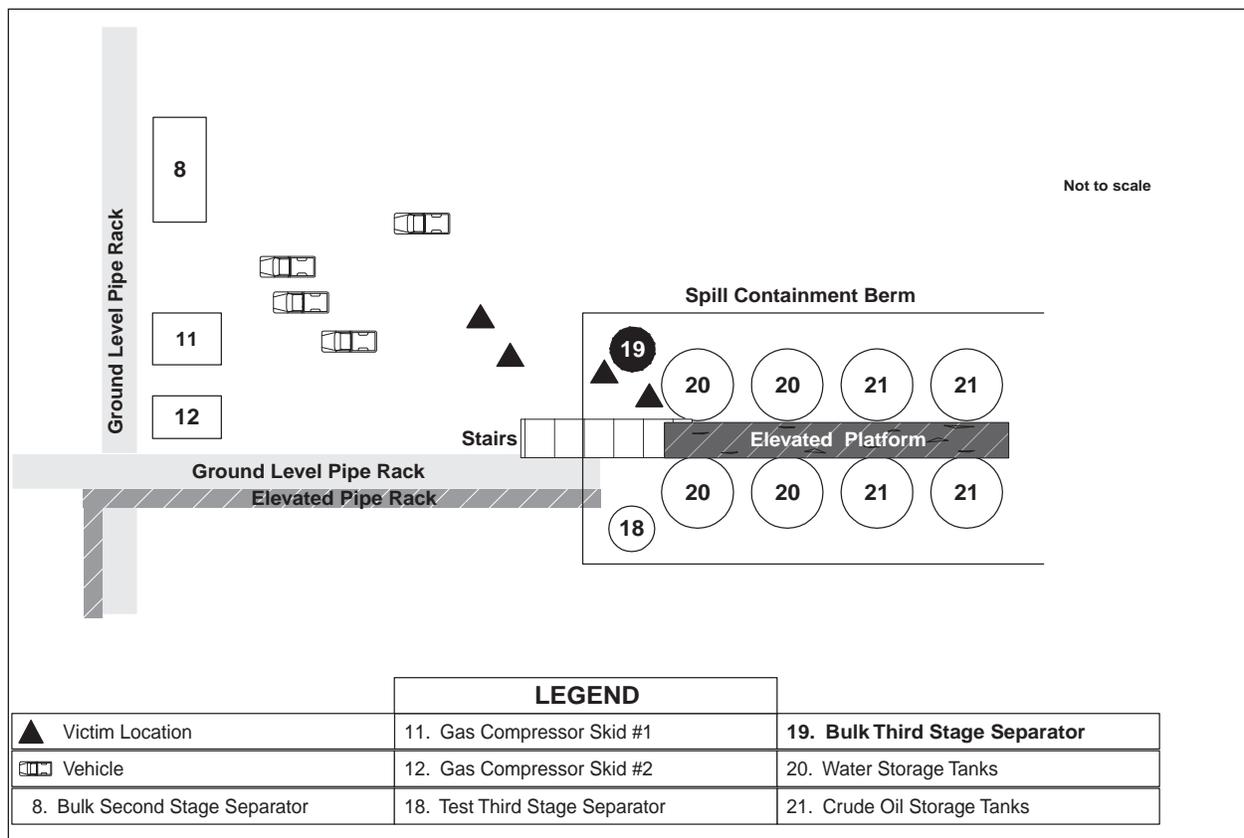
All four operators who were near the separator at the time of the failure were killed at once; in each case the cause of death was severe blast injuries. Figure 6 shows the approximate locations of the four victims, as found after the incident. The operator stationed near the header, about 190 feet from the separator, was thrown about five feet by the blast, and the construction supervisor was severely jolted as he exited his truck over 300 feet away at the pipeline valve. Both survived without serious injury.

Figure 6. Locations of the Four Victims Found after the Incident

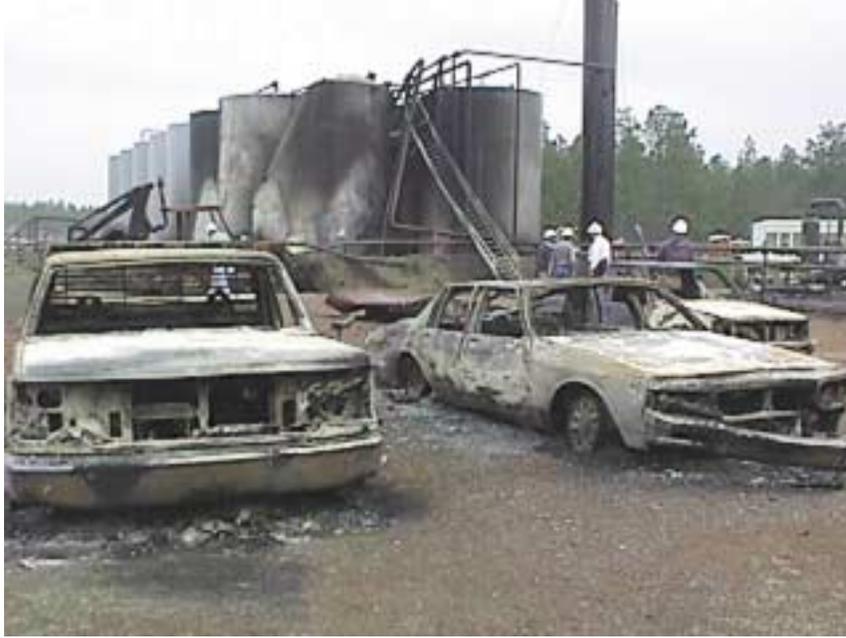
Figure 7. Damaged Vehicles and Storage Tanks

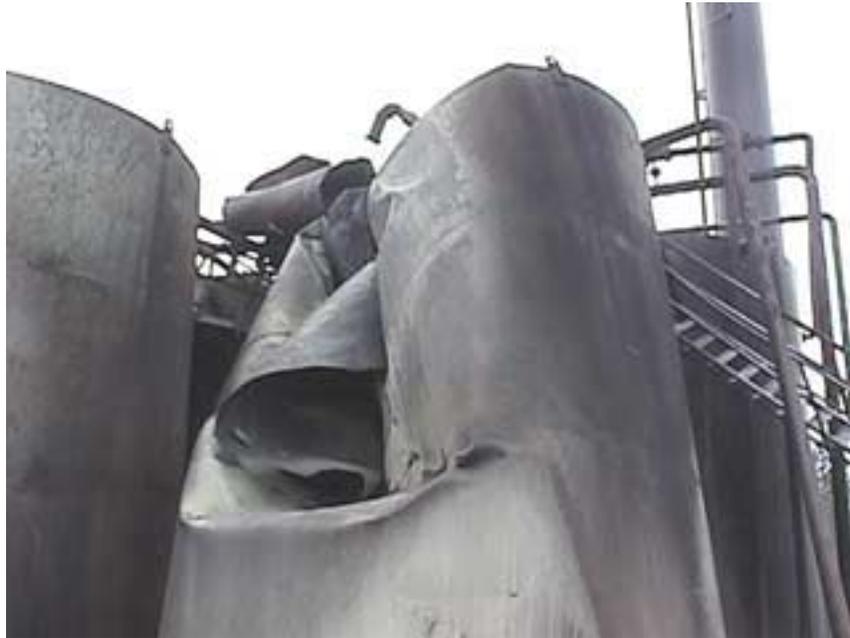
Figure 8. Damaged Water Storage Tank with Fragment of Third-Stage Separator

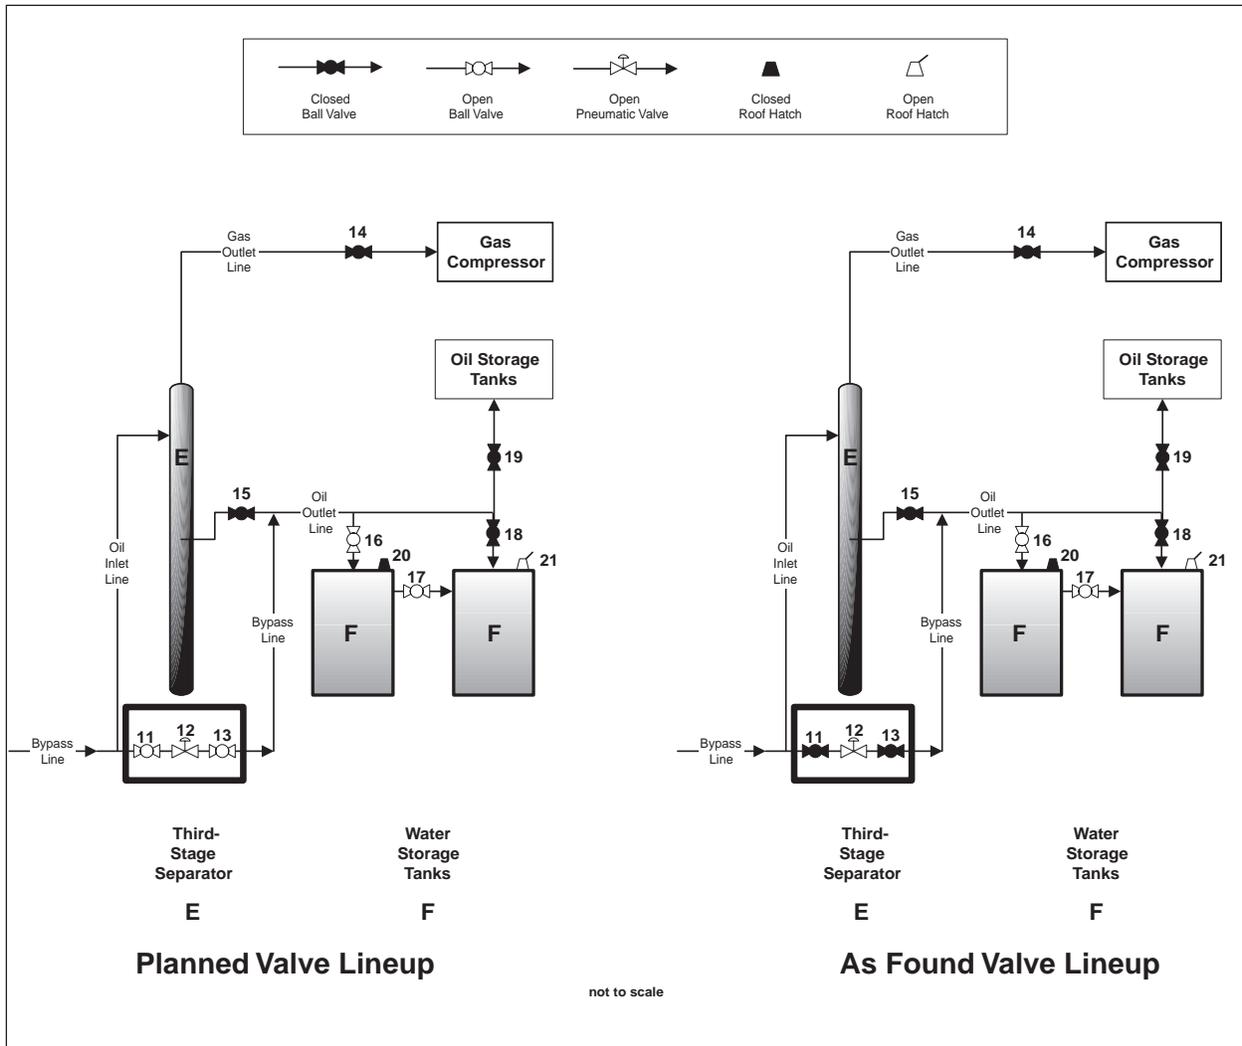
Soon after the fires stemming from the incident had been brought under control, Louisiana State Police inspected the area around the failed separator. They were accompanied by the Sonat production and construction supervisors. It was then discovered that, in contrast to the planned valve alignment, valves **11** and **13** were actually in the closed position.

Figure 9. Comparison of Valve Alignments as Planned and as Found after the Incident

Similarly, the timing of the closure of valves **11** and **13**, which triggered the vessel failure, could not be absolutely determined.²⁸ These two valves were opened in the morning but then closed early in the afternoon prior to the purging of the Bulk Train separators. The valves were not continuously monitored during most of the day. It is possible that the valves were not reopened as intended prior to the final purging process, and remained closed until vessel failure finally occurred. Alternatively, the valves may have been correctly opened during the final valve alignment, only to be manually closed later. However, no surviving personnel reported seeing the valves closed during any part of the final purging process, and there was no operational reason to close the valves once the purging was under way. The surviving supervisors did not report giving any such instruction, nor were any Bulk Train valve realignments whatsoever planned during the final purging process. Valves **11** and **13** were not intended to be closed once the Bulk Train entered routine production.²⁹
